# Maryland Historical Trust Maryland Inventory of Historic Properties number: 8-454

Historic Bridge Inventory Maryland State Highway Administration Maryland Historical Trust Name and SHA No. BC 2201 Location: Street/Road Name and Number: Liberty Heights Avenue over CSX Railroad Tracks City/Town: Baltimore Vicinity \_\_\_ County: \_\_\_\_ Ownership: \_\_State\_\_County\_X\_Municipal\_\_Other This bridge projects over: \_\_Road\_X\_Railway\_\_Water\_\_Land Is the bridge located within a designated district: \_\_yes X no \_NR listed district\_\_NR determined eligible district \_locally designated\_\_other Name of District **Bridge Type:** Timber Bridge \_Beam Bridge\_\_Truss-Covered\_\_Trestle \_Timber-and-Concrete \_Stone Arch \_\_Metal Truss \_\_Movable Bridge \_\_Swing \_Bascule Single Leaf\_Bascule Multiple Leaf \_\_Vertical Lift\_\_Retractile\_\_Pontoon X Metal Girder X Rolled Girder \_\_Rolled Girder Concrete Encased \_\_Plate Girder \_\_Plate Girder Concrete Encased \_\_Metal Suspension Metal Arch

MHT Number B-4547

B-4547 Bridge 2201 Liberty Heights Avenue over CSX Railroad Tracks Baltimore City Baltimore West Quad

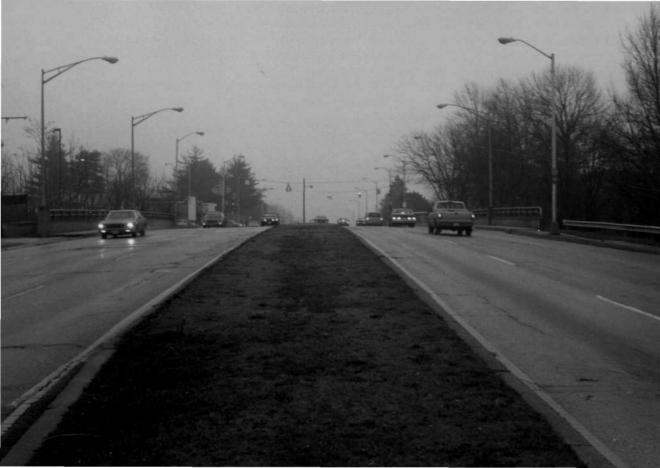
Inventory	#	B-	45	4
III TOILLOIS	"		_	-/

Name 2201-LIBERTY HEIGHTS AVENUE OVER CSS County/State BALTIMORE CITY/MARYLAND Name of Photographer TIM SCHOEN
Date 195
Location of Negative SHA
Description WEST APPROACH
Number 20 of 25 1 & 4

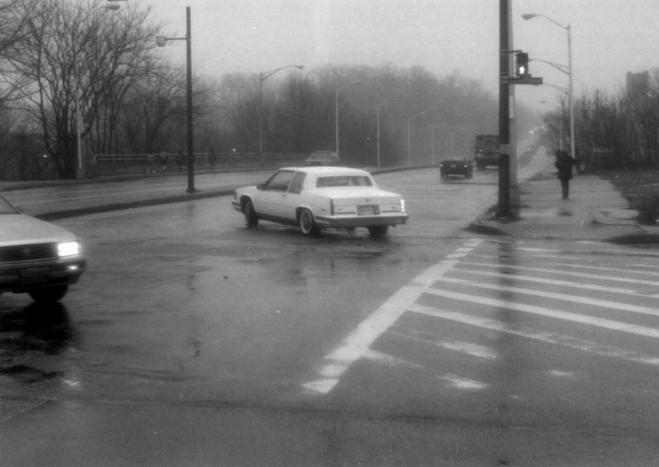
Inventory # B-4549
Name 2201- LIBERTY HEIGHTS AVENUE OVER CSX County/State BALTIMORE CITY/MARYLAND Name of Photographer TIM SCHOEN Date 195
Location of Negative SHA
Description EAST APPROACH
Number 21 of 25 2 of 4

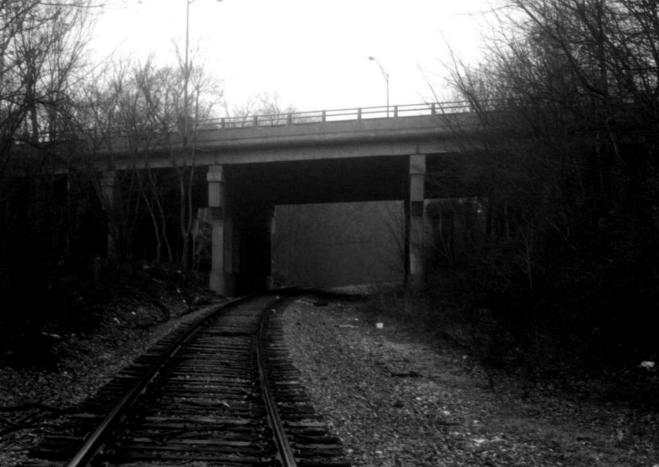
# Inventory # B - 45 47

Name 2201- LIBERTY HEIGHTS AVENUE OVER CS	×
County/State BALTIMORE CITY/MARYUANO	
Name of Photographer TIM SCHOEN	
Date 1/95	
Location of Negative SHR	
Description SOUTH ELEVATION	_
	_

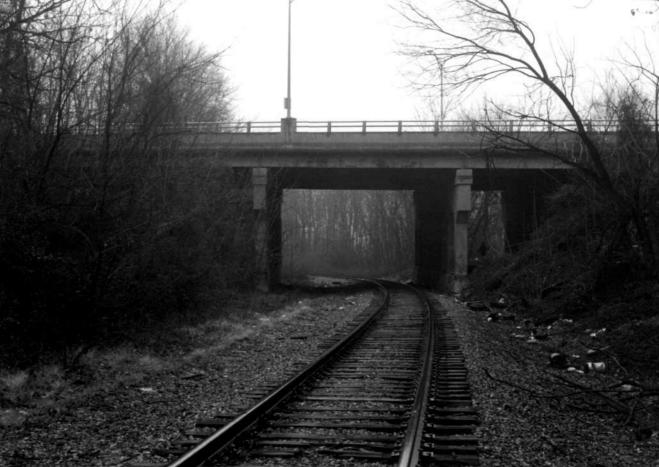
Inventory #	B-4545
J

LIBERTY HEIGHTS AVENUE OVER CS BALTIMORE CITY/MARYLAND
Name of Pho	otographer TIM SCHOEN
Date 1/9	5
- 1	
Location of	Negative SHR
	Name Applicable and the rest assumptions and
Description	NORTH ELEVATION
